Docket No. 217 – Development and Management Plan Inspection

Northeast Utilities Service Company Certificate of Environmental Compatibility and Public Need for the construction of a 345-kV electric transmission line and reconstruction of an existing 115-kV electric transmission line between Connecticut Light and Power Company's Plumtree Substation in Bethel, through the towns of Redding, Weston, and Wilton, and to the Norwalk Substation in Norwalk, Connecticut.

Date: June 1, 2006

Location: Transition Stations: Hoyts Hill, Archers Lane, Norwalk Junction

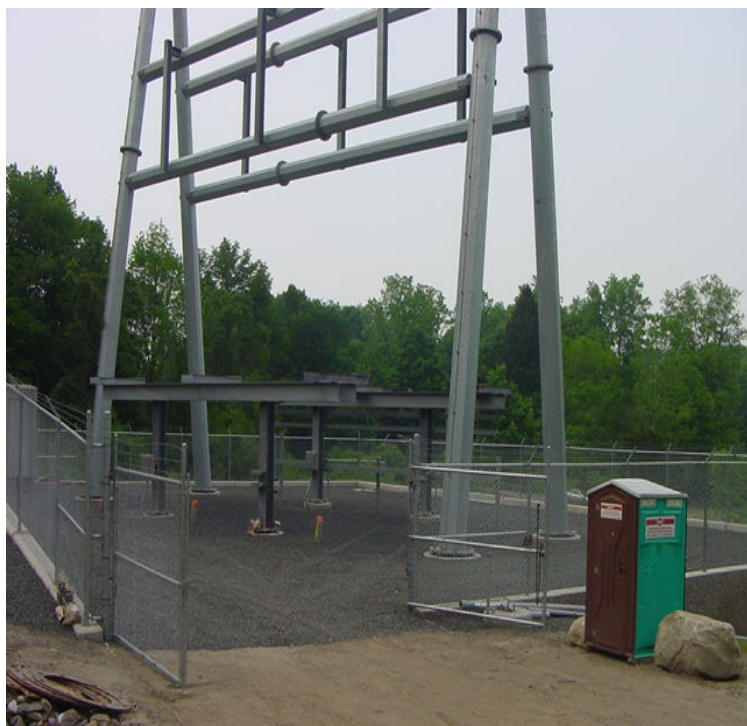
Hoyts Hill Transition Station: Photo on the left shows a view of the station pad. Active work was not observed at the time. Photo on the right shows the northern slope with good grass growth. 6/1/06

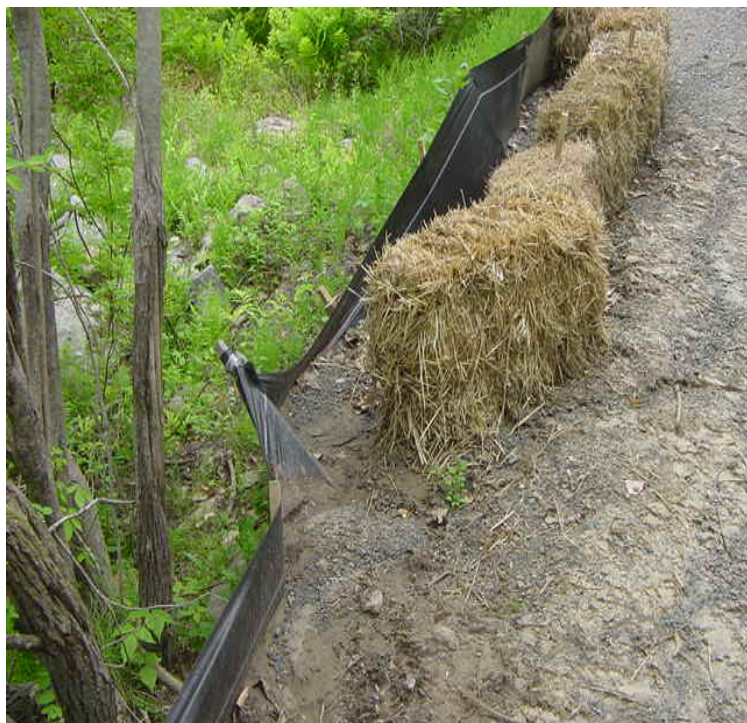
Archers Lane: Photo on the left shows a spot along the silt fence in the overhead ROW past the second wetland crossing. Washouts from the road are overtopping the fence here. Photo on the right shows the view into the station from the ROW. 6/1/06.

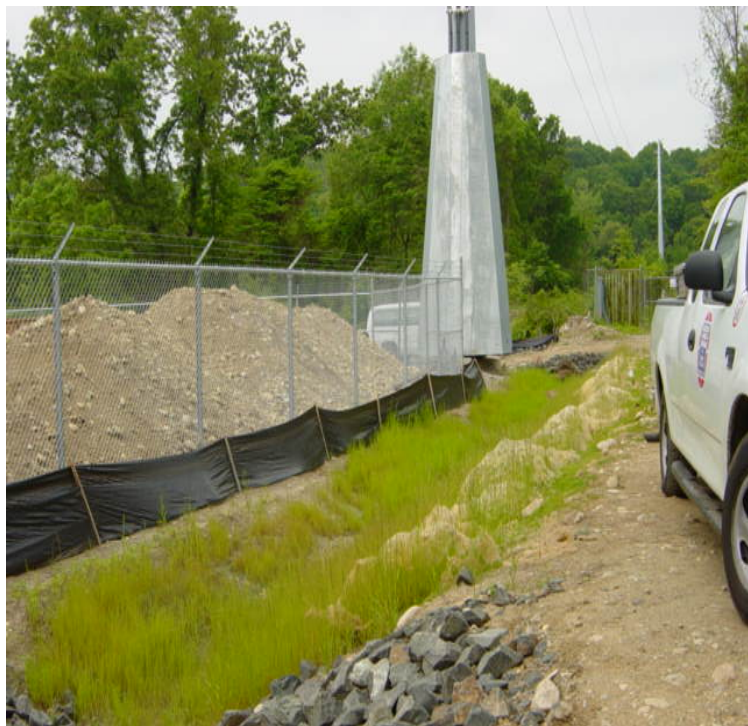
Norwalk Junction: Photo on the left shows the swale with increasing grass growth. Photo on the right shows the non-project related berm along the perimeter fence. 6/1/06.

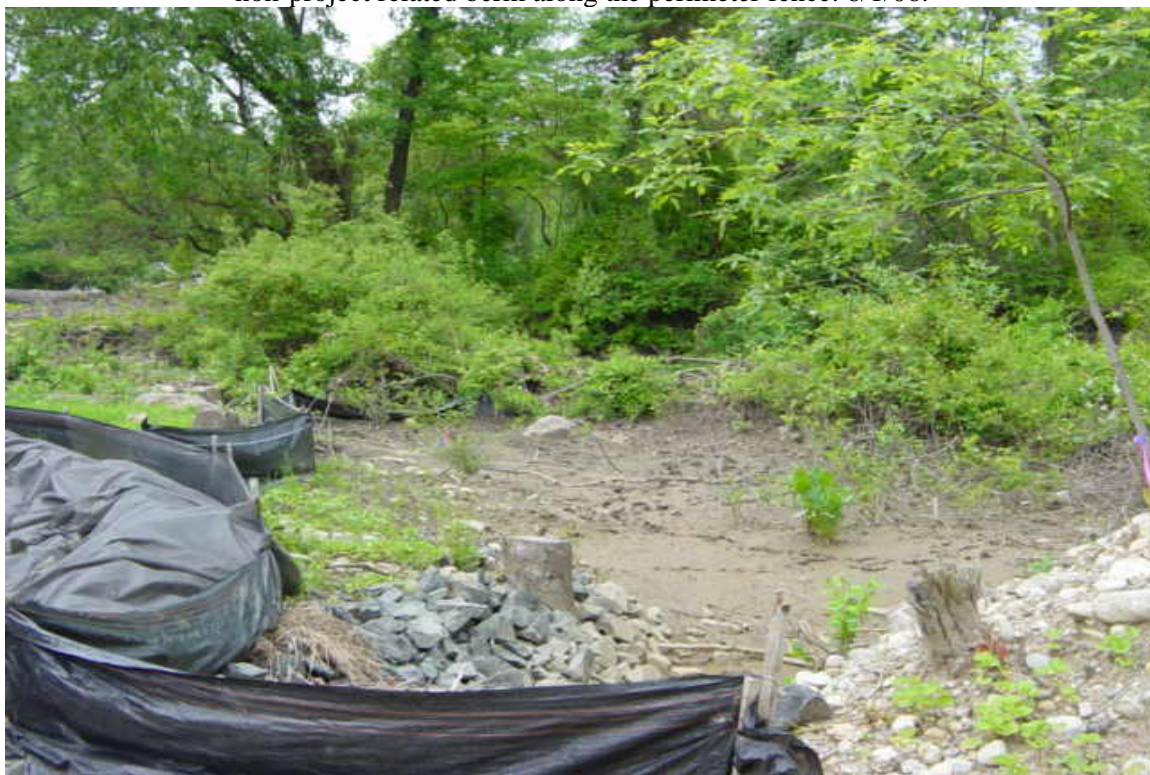
Photo shows where the swale enters the wetland area at the headwall. Some silt has settled out here but wetland plants are returning. If possible, sediment should be cleaned out of the rock at the outlet by hand. 6/1/06.
